Navajo Abandoned Uranium Mine

Site Screen Report

Harry Walker No. 19 AUM Site

January 2011

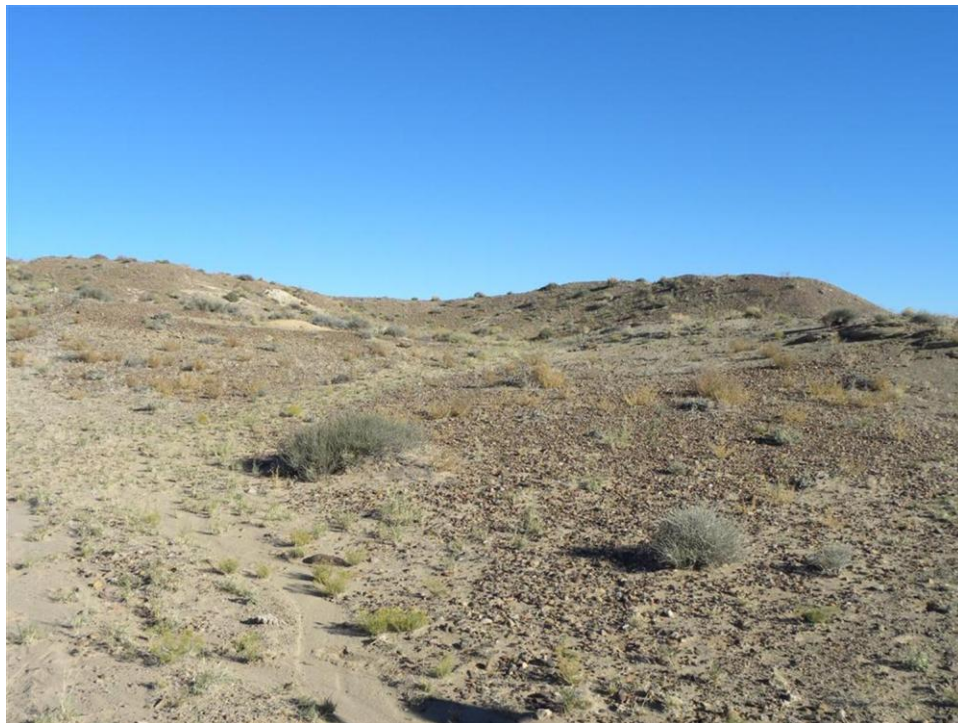
Photo 1. Harry Walker No. 19 mine site

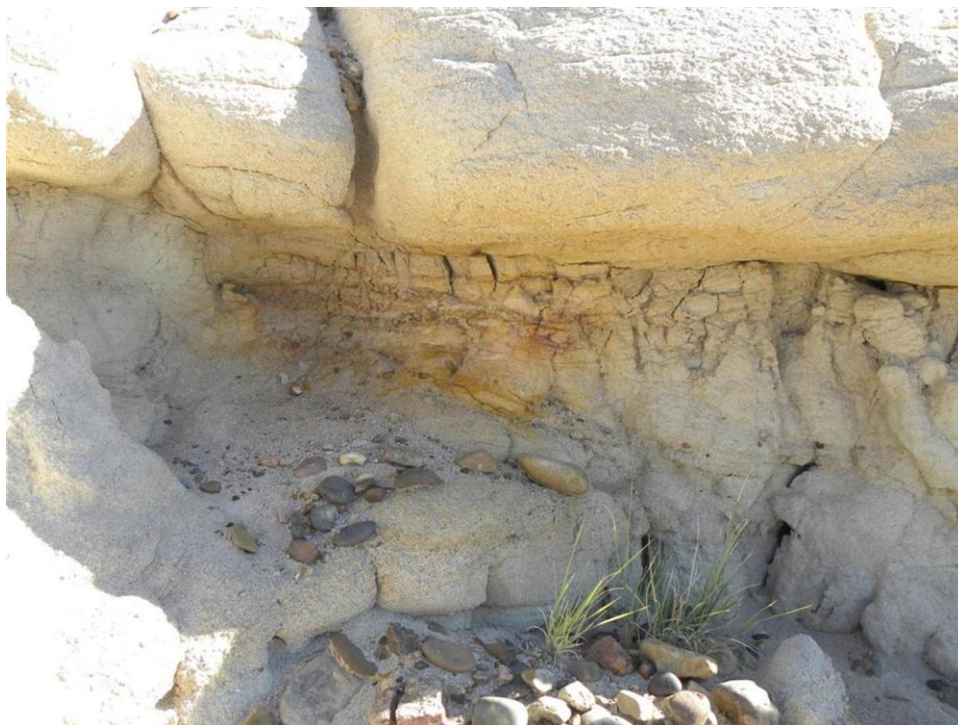
Reclamation cap, site has been reclaimed but exposed material in southern area due to erosion

Photo 2. Harry Walker No. 19 mine site, exposed ore

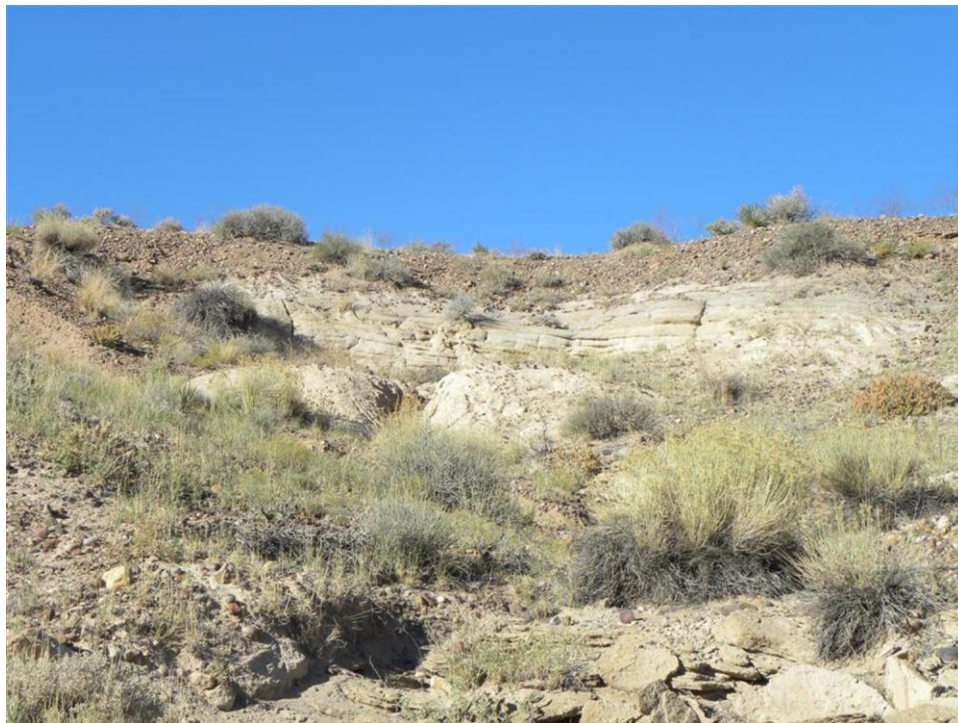
Waste pile 3' x 8' x 1.5', yellow-brown fine material

Photo 3. Harry Walker No. 19 mine site, waste pile

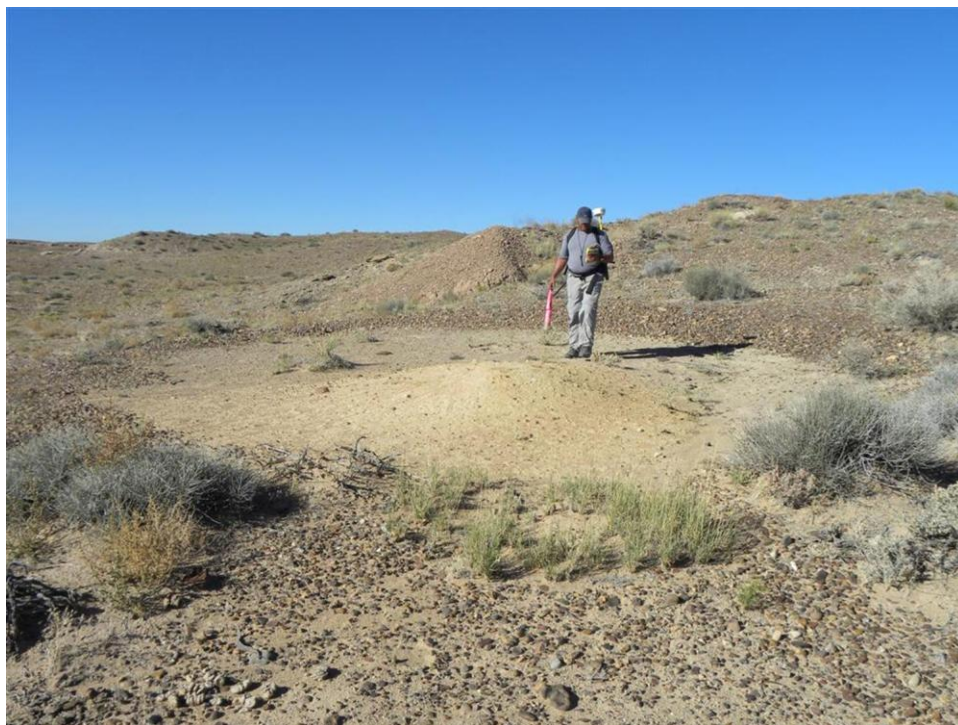
Photo 4. Harry Walker No. 19 mine site, elevated gamma radiation readings
